The crash of XD864.

Valiant BK1 XD864 crashed on the disused airbase at Spanhoe near Haringworth Northants, with the loss of five crew at 10.38 BST on the 12th of August 1960, three minutes after take off from the V-Bomber base at RAF Wittering, Cambs .

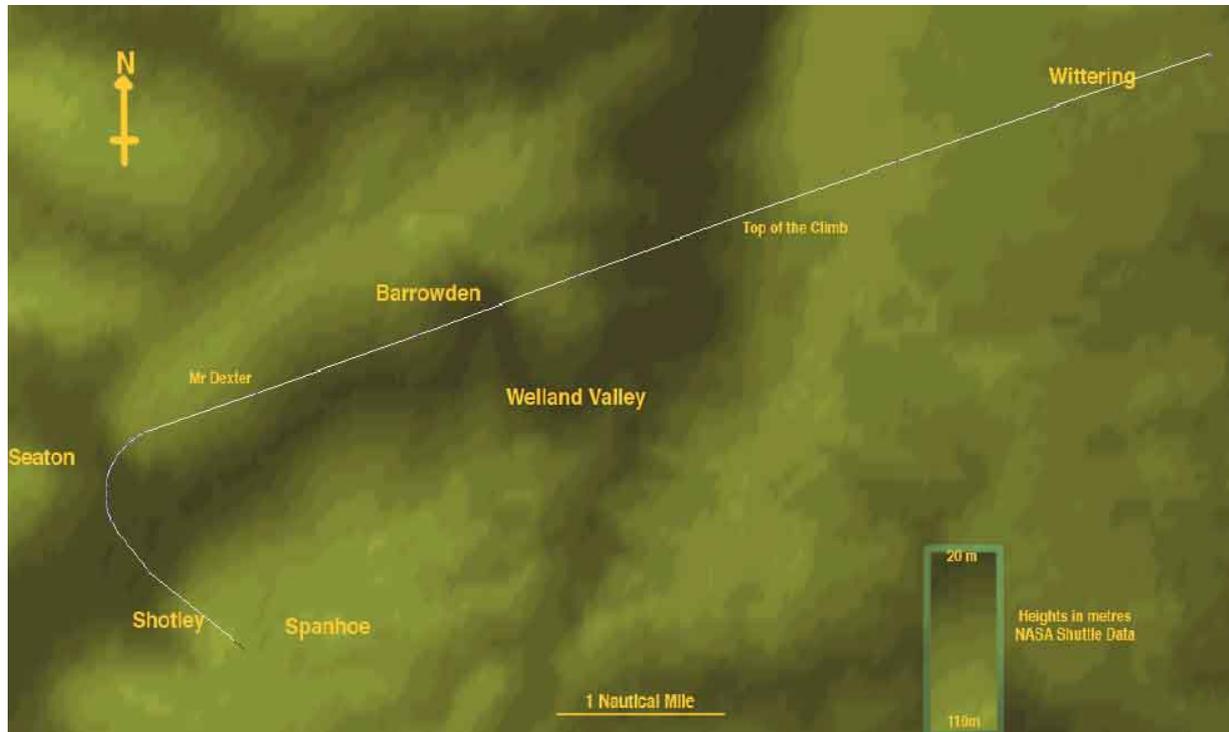
Although certain parts of Appendix T are now missing it is possible to recreate the flight path in the same way the BoI do, using witness statements, and plotting the results on an OS map of the area.

Here is a reconstruction showing the topography using NASA elevation data.

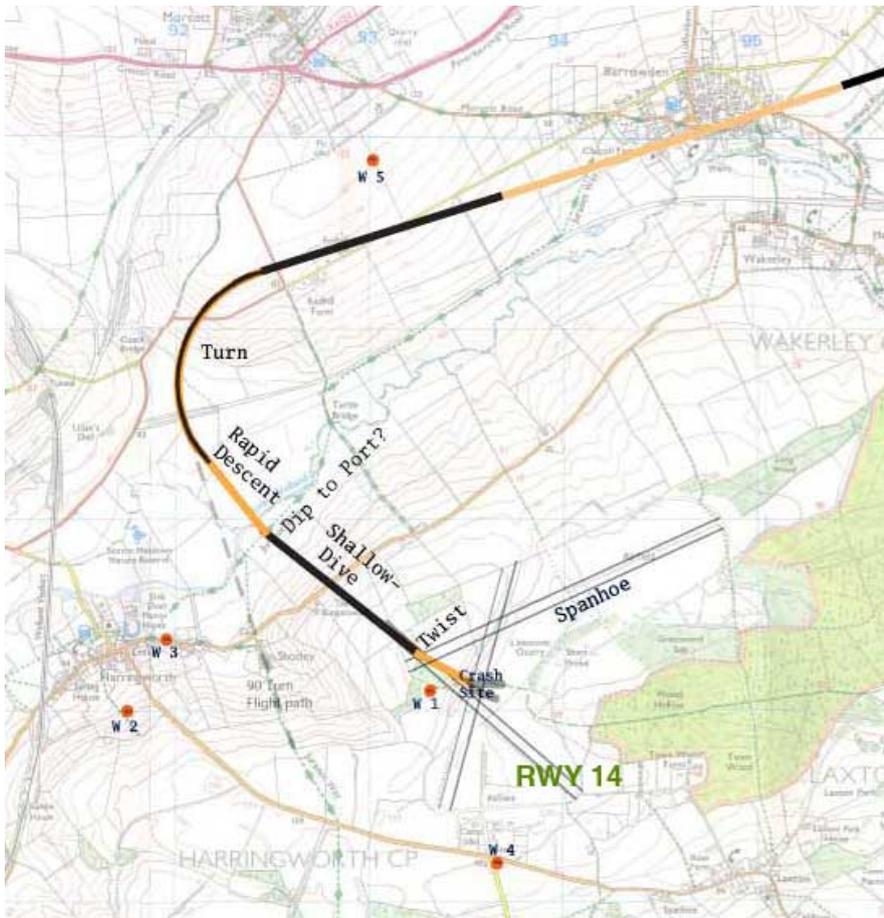
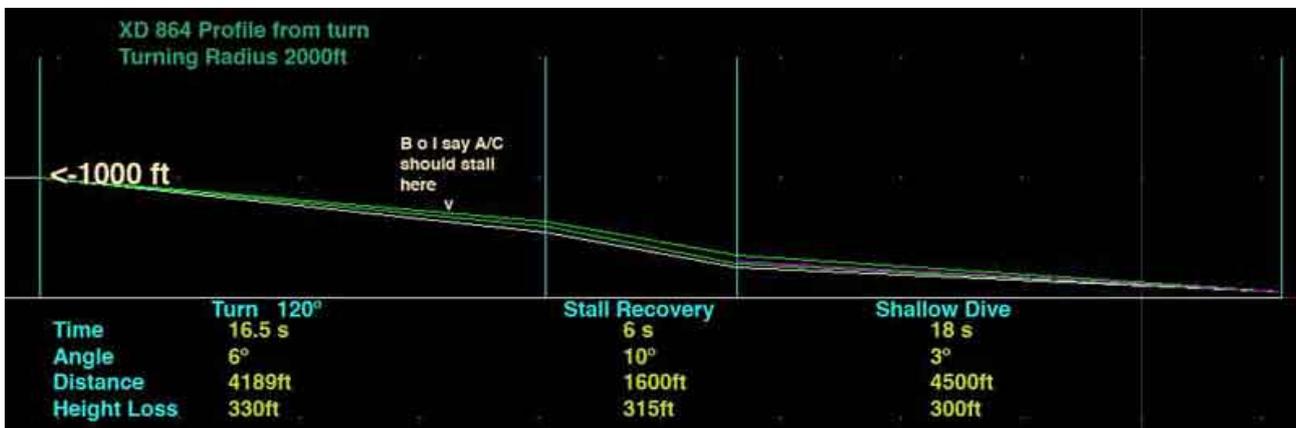
because at first glance the reconstruction throws up another possible narrative, that of an attempt by the Captain to perform an emergency landing on the disused runway 14 at Spanhoe,

The A/c stalled out of a turn in line with a runway and had lost enough height so that, with a stall recovery (rapid descent) and a final adjustment of course, ended up in an 18 second slow, shallow descent, in line with a runway, with the engines idling, in other words what you do in a glide approach to a landing.

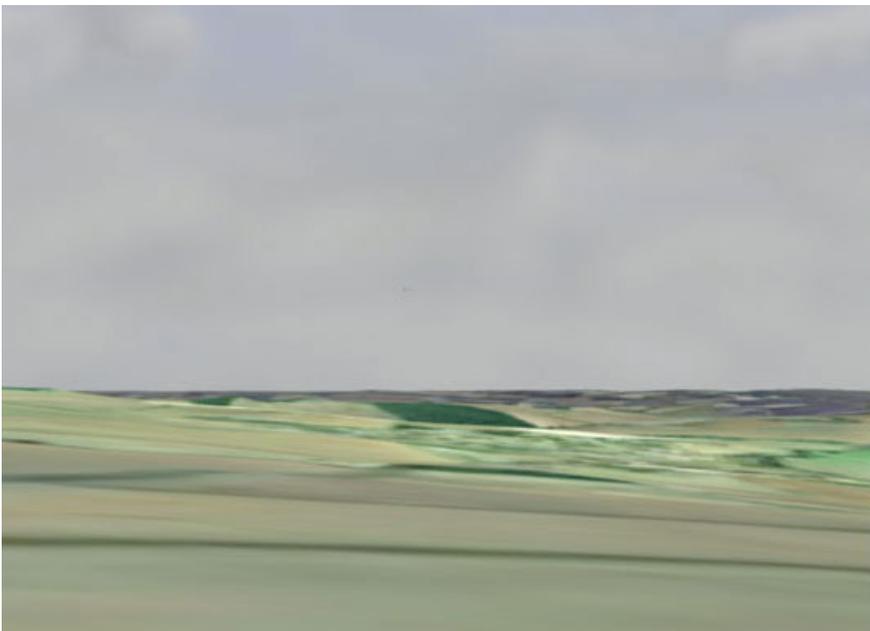
Here (below) is what Mr Dexter would have seen when the BoI say Mr Dexter heard the irregular engine sound, (around 16 seconds from the top of the climb). The A/c is a speck above the lower left corner of the wooded area in the centre of the image, the A/c is flying **across** the Welland Valley at this point in the flight and not along the valley as Mr Dexter states.

It is impossible to identify the type of this A/c, and it appears to be slowly climbing towards the top right hand corner of the image, making the

determination of course and eventual destination impossible also.

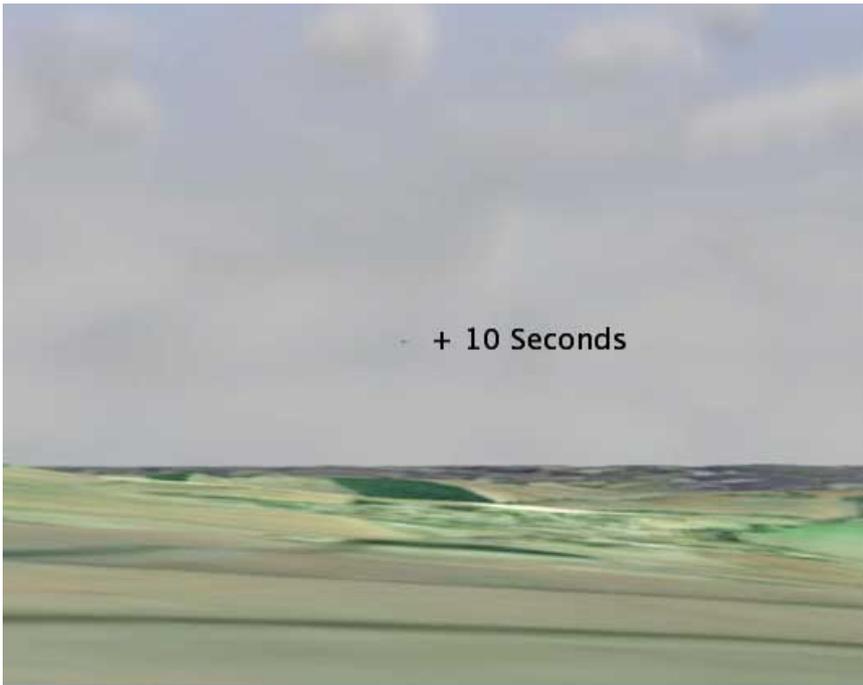
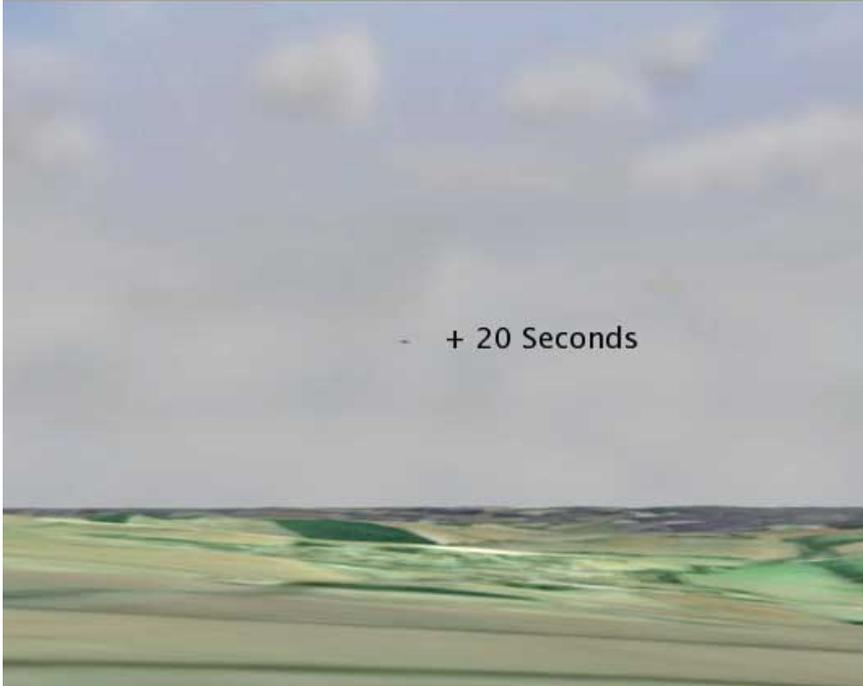
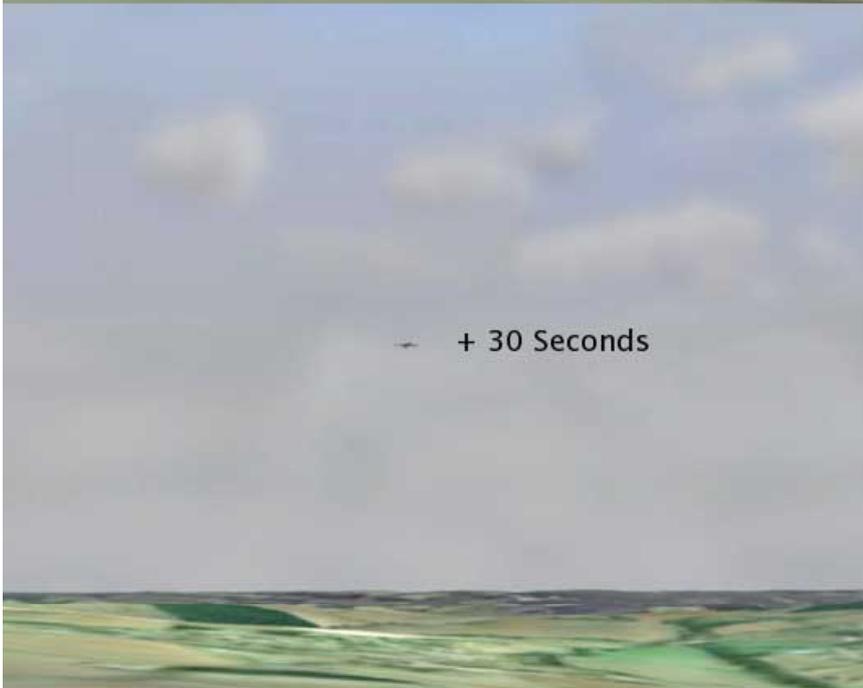
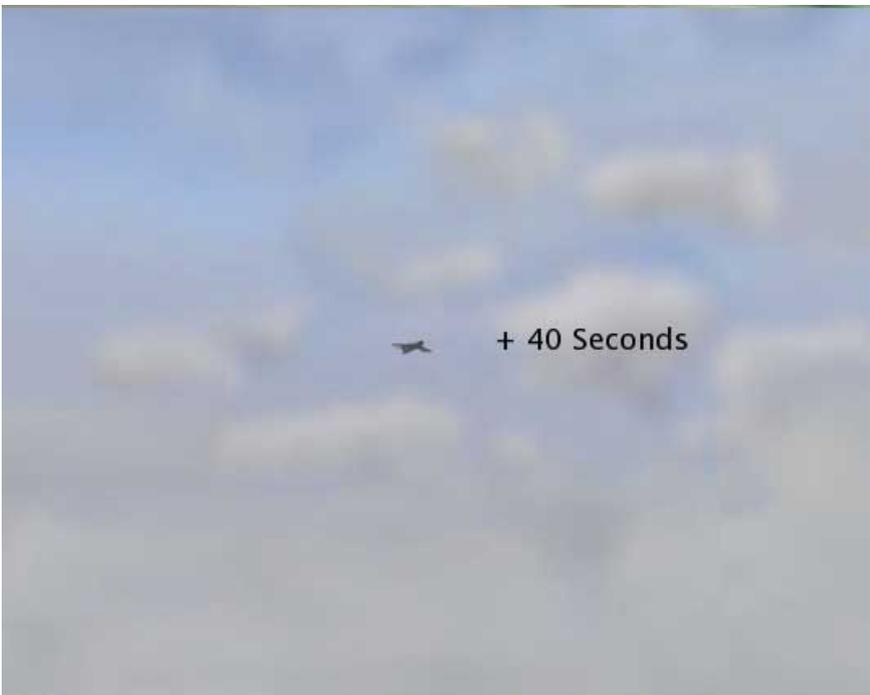
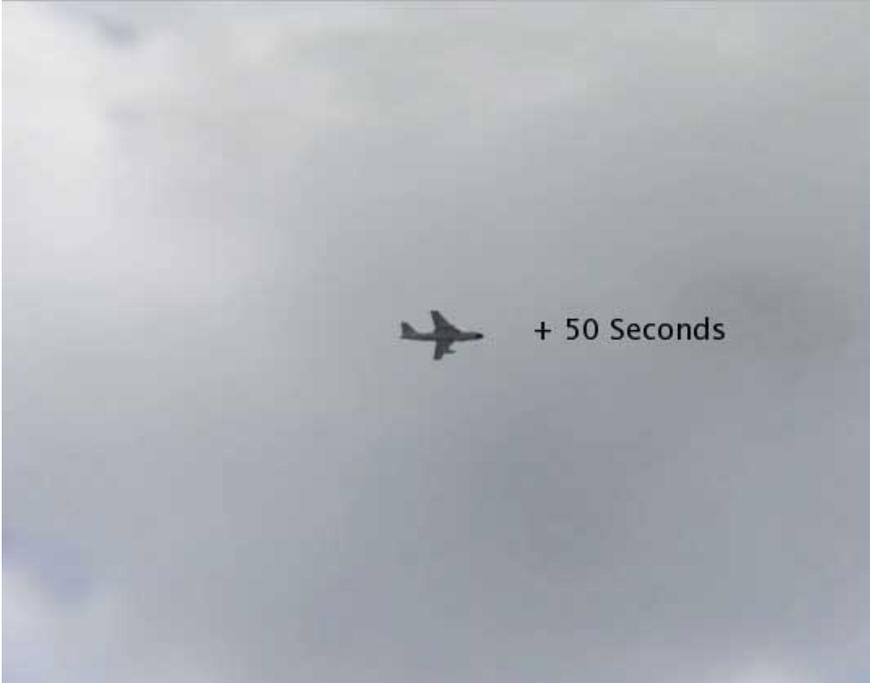
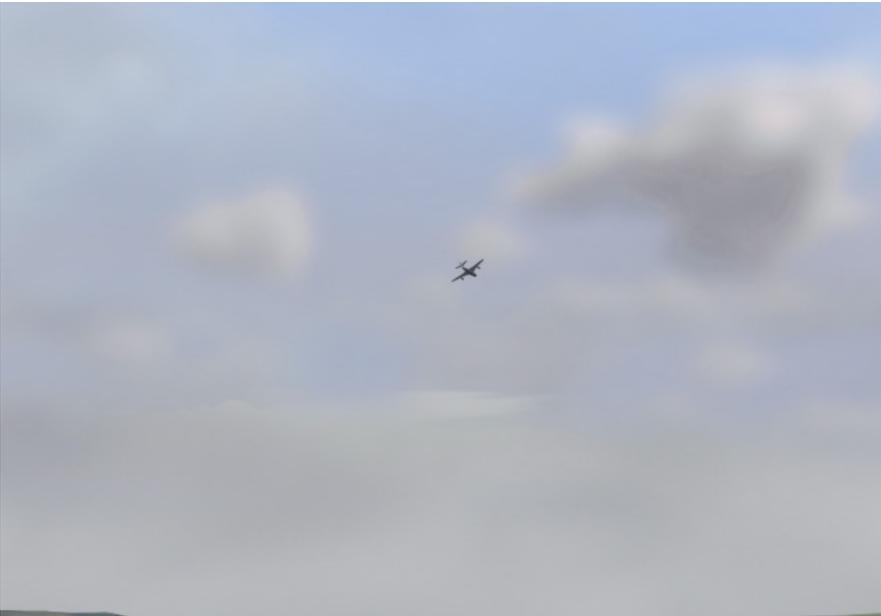
Here (below) is what Mr Dexter would have seen at intervals of 10 seconds for the next 50 seconds starting at the top of the climb. This sequence is taken from a Hi- resolution version of the movie [Witness 5.mp4](#)*. This is the phase of the flight edited out of the BoI narrative, described by the BoI as a "short period" of level flight that took a "very short time", the time line edit begins after the top of the climb ...

and ends here, approximately 60 seconds later entering the turn, at the end of the "short period" of level flight..

Viewing the above image sequence, it's apparent that the direction of the A/c is only discernible by about +20 seconds, that it is flying along the

Valley by +30 seconds, its height by about +40 seconds and its type a few seconds later. The only time therefore that Mr Dexter could possibly make the statement:-

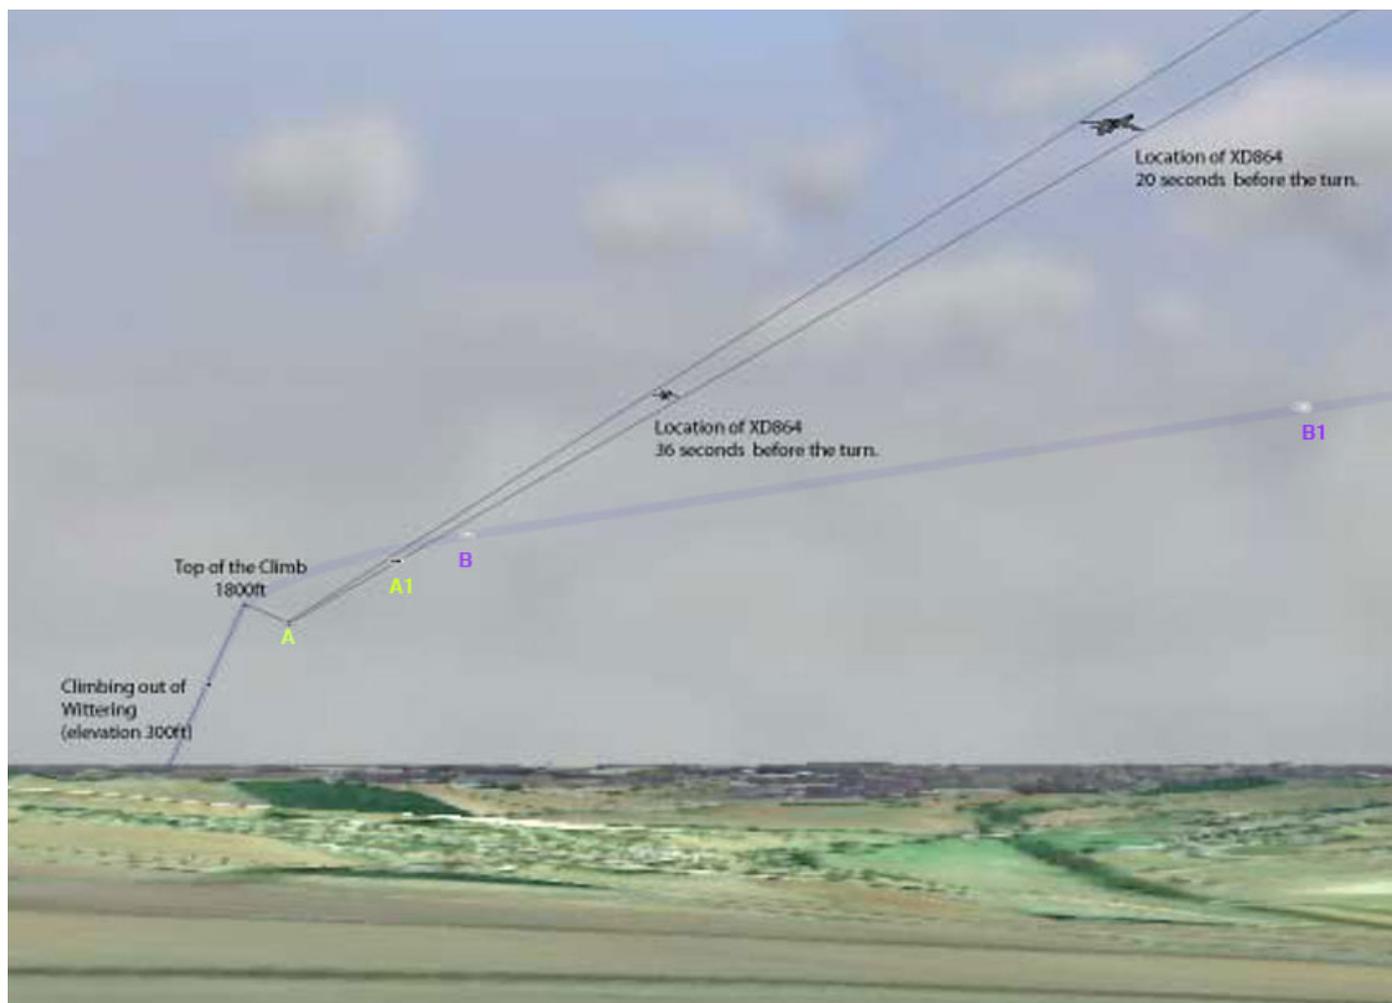
Flight path projection from Witness 5's point of view showing flightpaths of West bound A/c and XD864 (Based on BoI pp 60-63 and the reconstruction of the flight)

The tracks, reproduced in the image below, are from the point of view of Mr Dexter. The track of XD864 ("A") is contained within the black lines, the track of a West bound A/c is the blue line ("B"). For the take off and climb to 1800 ft the flight paths are shared. The points "A" and "B" are where the A/c would be on their respective flight paths at the time the irregular engine sound attributable, according to the BoI, to the throttle back at the top of the climb, would reach Mr Dexter's location (16 seconds delay in sound reaching Mr D). Points "A1" and "B1" are where the A/c would be some 16 seconds later (48 seconds before the turn in the case of A/c at position "A1").

Again it is clear that Mr Dexter first notices XD864 very much later in the flight than the BoI say Mr Dexter first sees the A/c. It would be impossible for an observer at Mr Dexter's location to decide which flight path an A/c at position "A" was following, but the BoI assume Mr Dexter somehow managed to do this, i.e. with the A/c 16 seconds from the top of the climb, it is very easy to confuse whether an A/c is climbing on T/o or heading East, West or "along" the Valley. The height of the A/c can only be resolved when the A/c has travelled at least another 30 or so seconds in the flight (36 seconds before the turn in the image above). Again this evidence supports the contention that the pilot was decelerating in readiness for a turn when Mr Dexter first notices the A/c and so in control of the A/c, selecting a power setting appropriate for the manoeuvre he was about to carry out, i.e. a 'normal' turn.
